GROUP	MODEL
ELE	2019-2022MY Niro EV (DE EV)
NUMBER	DATE
270 (Rev 1, 06/12/2023)	April 2023

TECHNICAL SERVICE BULLETIN

SUBJECT: **FLUSHING/REPLACEMENT FOR CLUSTER MESSAGE
"REFILL INVERTER COOLANT" (SA512)**

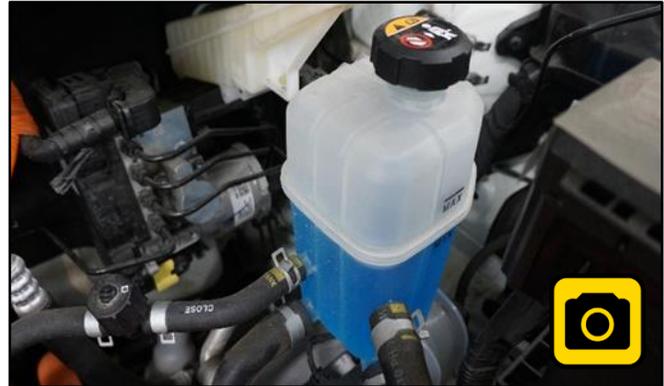
1. If the vehicle has General Type Coolant (green), **this service action does not apply.**

If the vehicle has Low-Conductivity Coolant (BSC-1) (blue), continue to step 2 to replace it with (BSC-2) to complete this service action.

Submit a KVID photo of the green coolant filled reservoir and use Op Code 230020R2.
